# PROVENTECHNOLOGIES, NEW WAYS OF THINKING

Director of Water Utilities Department  
City of Arlington

# CONCRETE WATER MAIN CONDITION ASSESSMENT PROGRAM

# LARGE DIAMETER SANITARY SEWER CONDITION ASSESSMENT PROGRAM

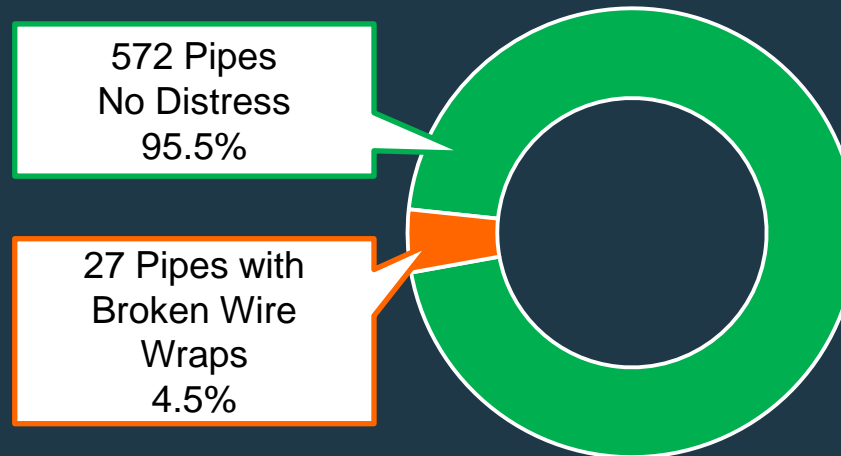
- Assessment Results
  - 599 pipe segments
  - 27 segments with wire breaks (4.5%)
  - 6 segments with 25+ wire breaks (1.0%)
  - Cost avoidance of \$7,000,000

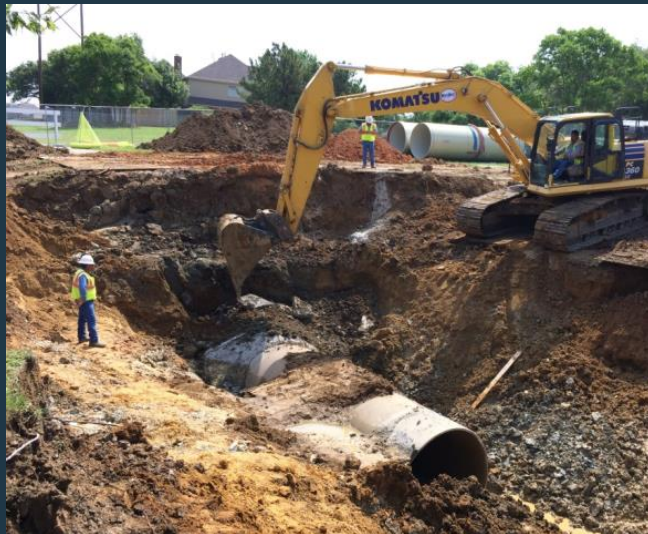
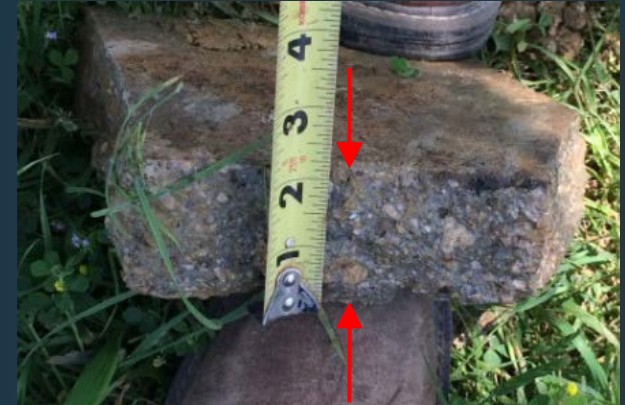
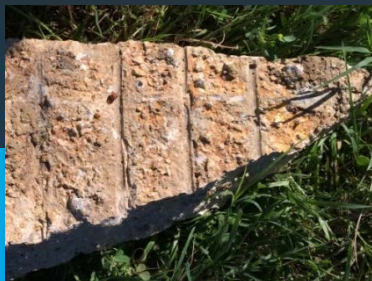
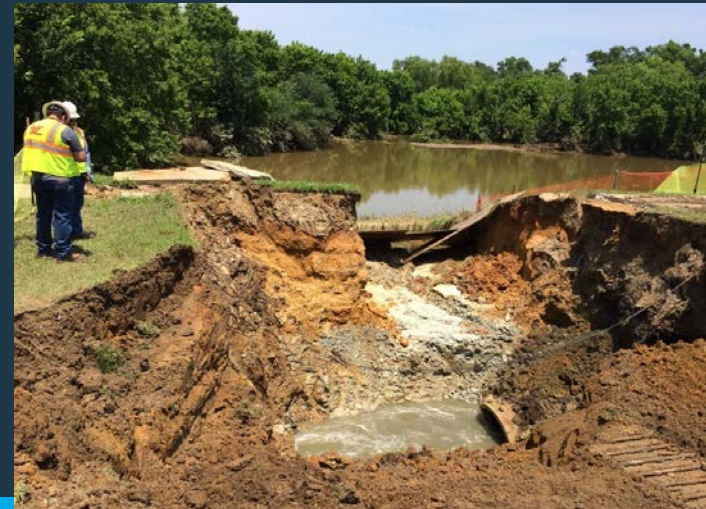
# 66-Inch Sanitary Sewer Failure

- Installed in 1983
- 66-inch RCP Sanitary Sewer
- Repair Cost \$138,000

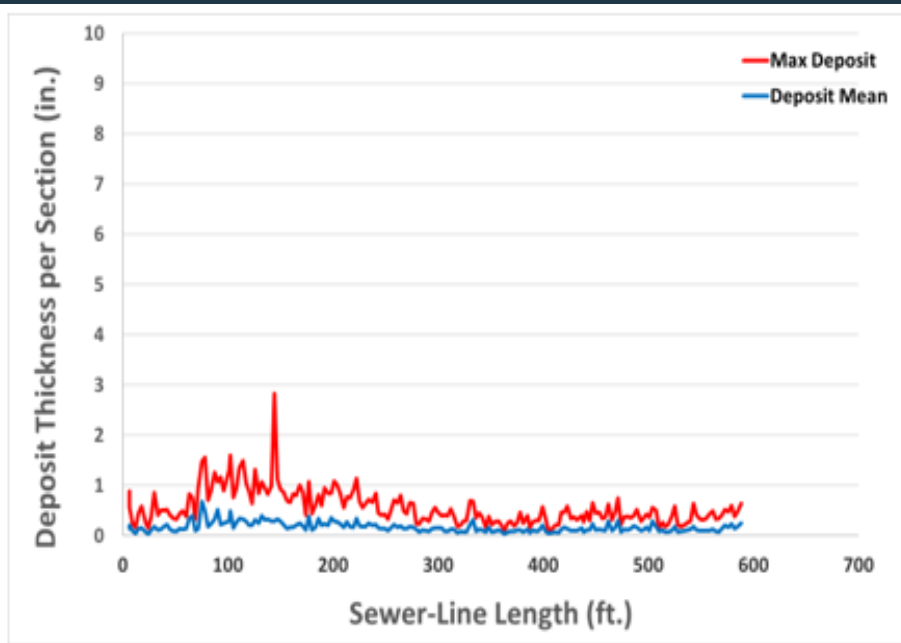
Figure A1.1.1: Deposit thickness per cross-section.

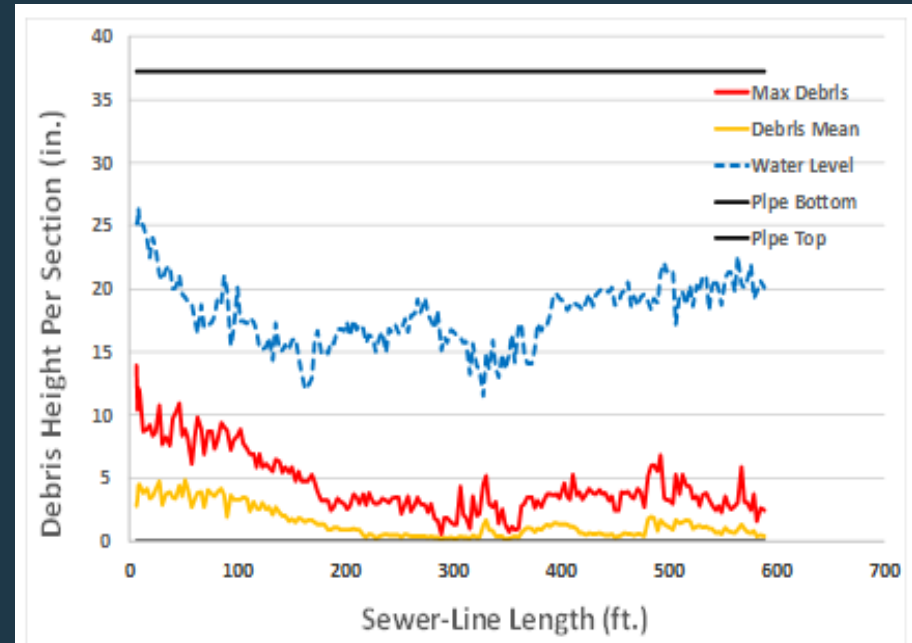
Figure A1.2.1: Debris height per cross-section.

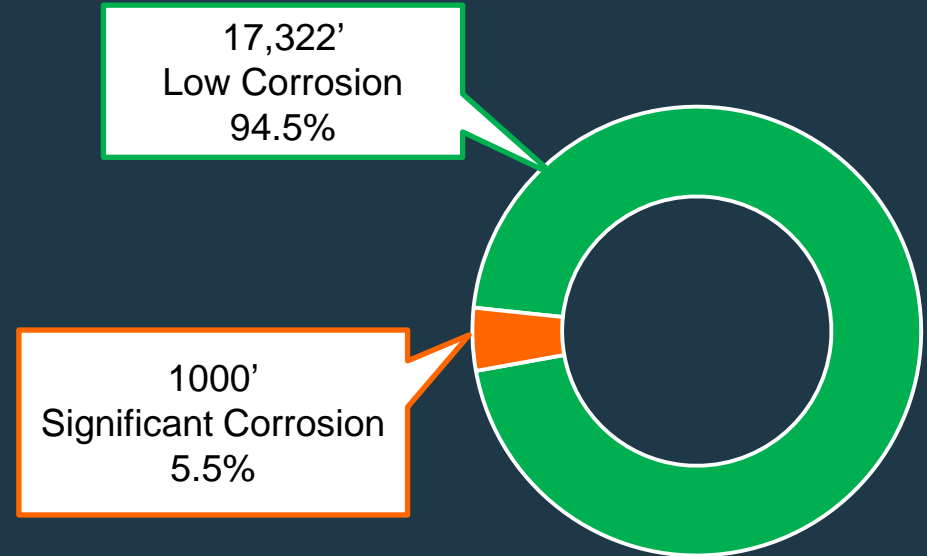
# 66-Inch Sanitary Sewer Failure Survey Results

- 1,000' Pipe with Measurable Wall Loss
- Abandoned Meter Station (H<sub>2</sub>S Point Source)
- Cost avoidance of \$17,097,000
