# Using AI and Emerging Technologies to Improve Resiliency of Underground Assets

February 5<sup>th</sup>, 2025  
SAME Fort Worth Post

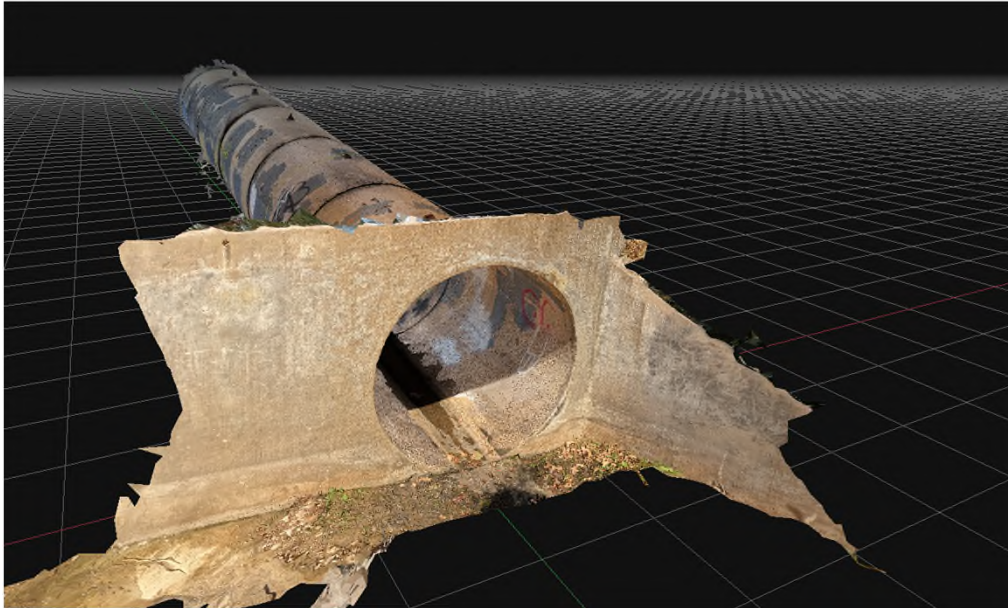
Storm Outfall

- 3D digital twins support inventory, condition evaluation, prioritization, & renewal

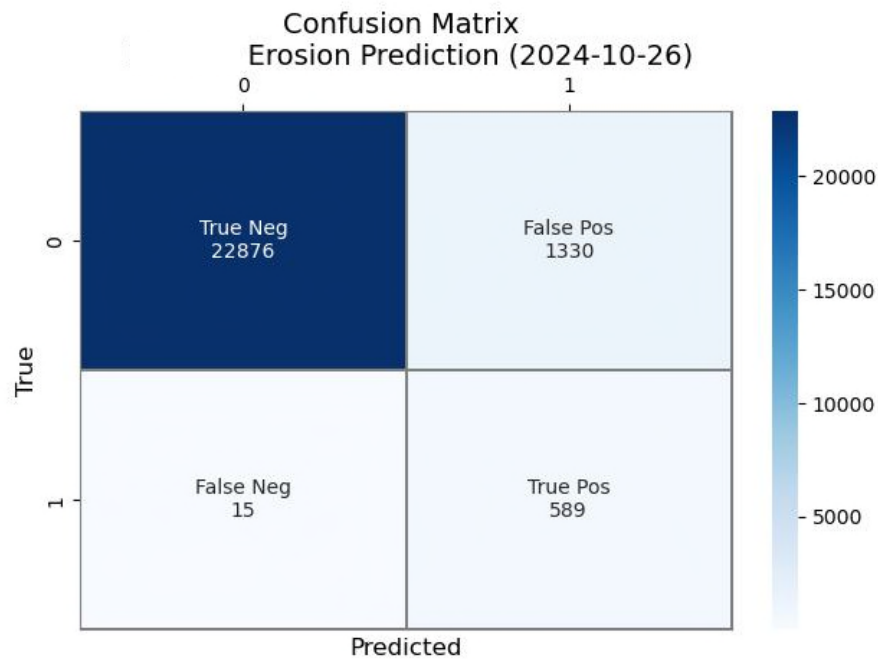
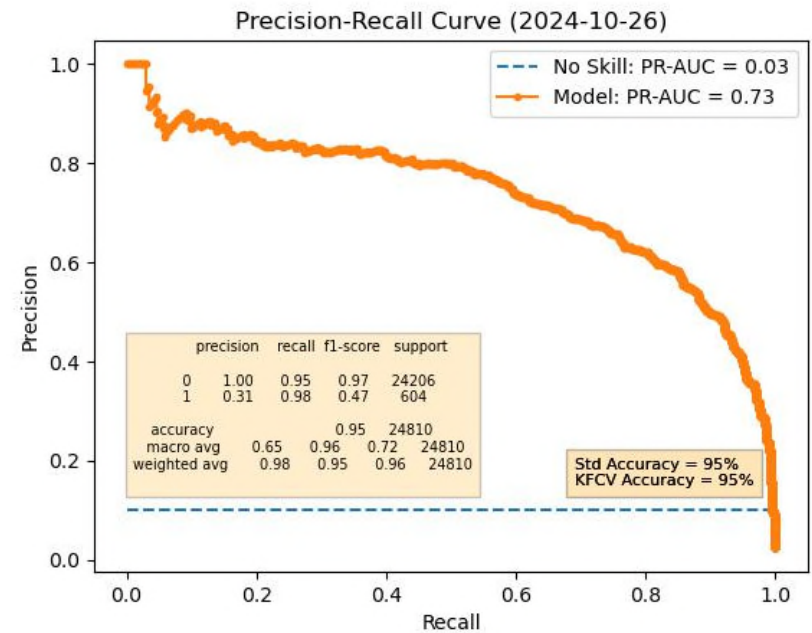
- Machine Learning Metrics

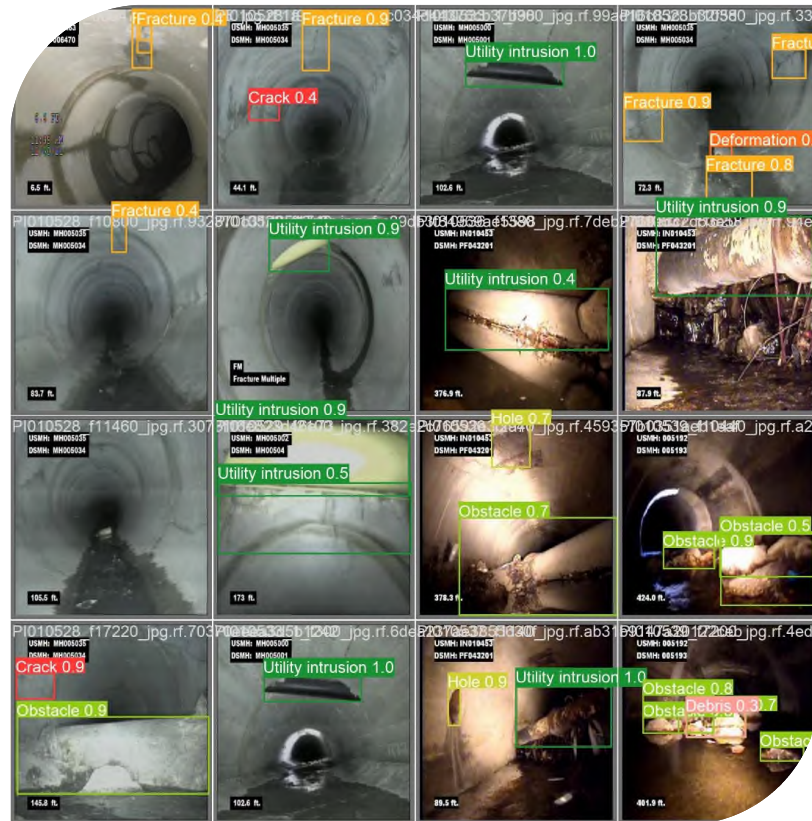
AI Defect QA/QC

- Pipes
- Access Points

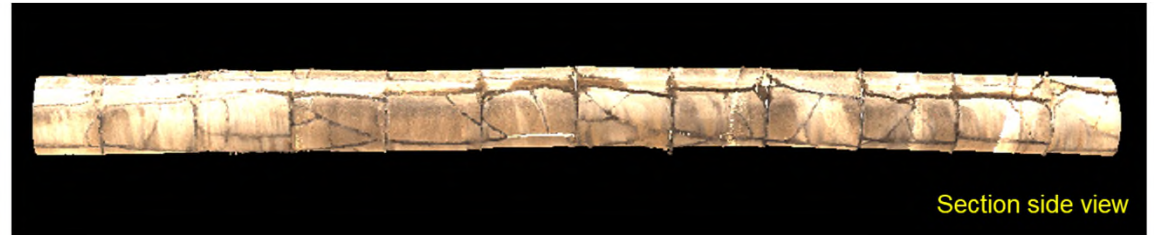
Section side view

## 3D Digital Twins, Scanning, Mapping Horizontal Assets

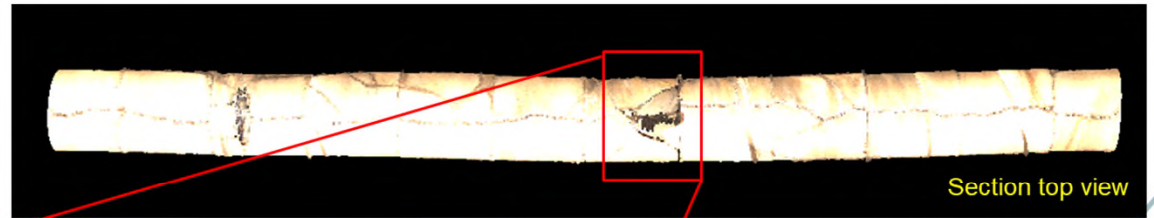
Section top view

Date: 10/22/2024  
Location: Fort Worth, TX  
Total Length: 256ft

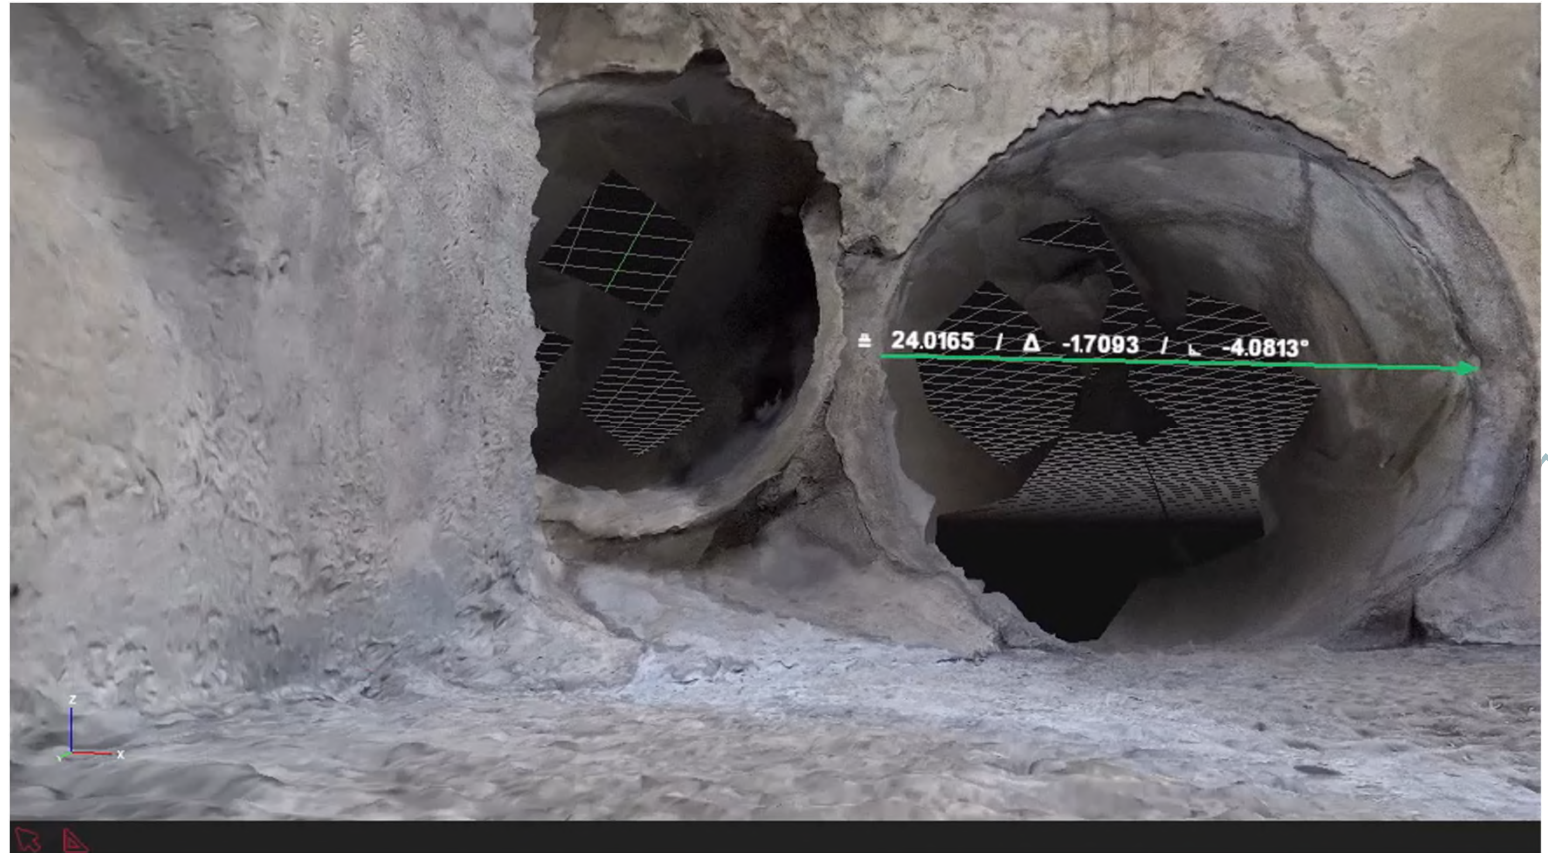
3D Scanning,  
Inspection,  
Scoring, &  
Topology

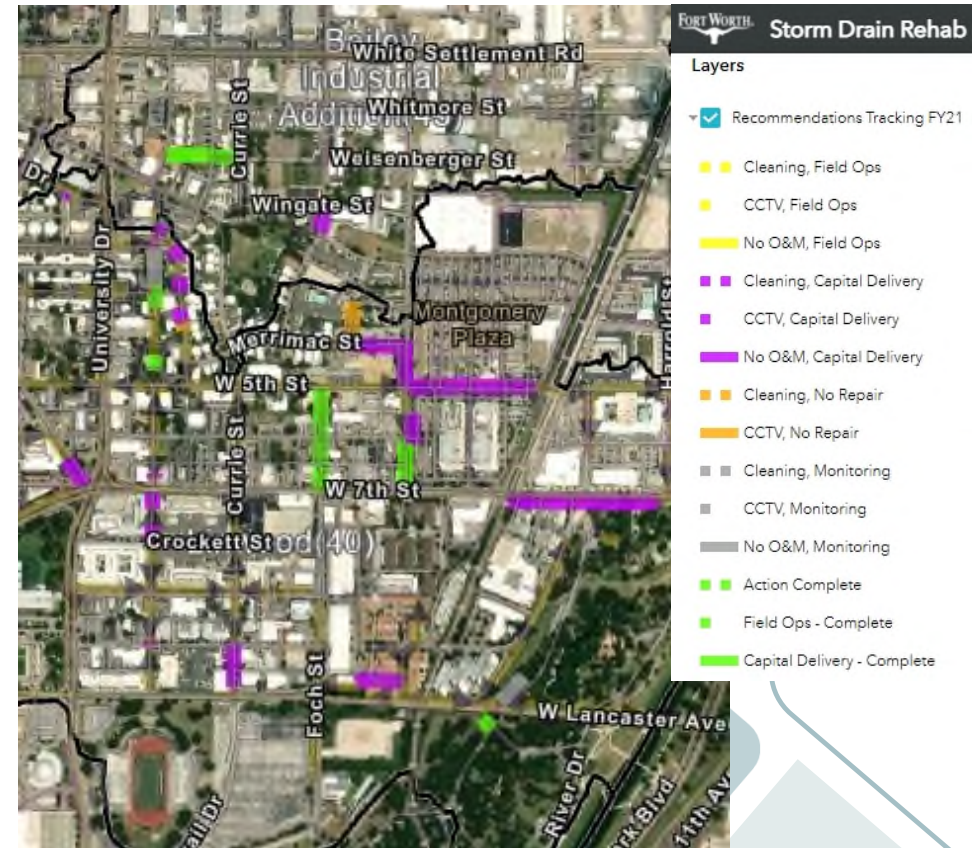
Prioritized Recommendations in GIS

- Data-driven & standardized in GIS or web platform
- Assets evaluated in detail; key inputs for corrective action, responsible group
- Assign corrective action & responsible group (O&M vs structural; City staff vs CIP)

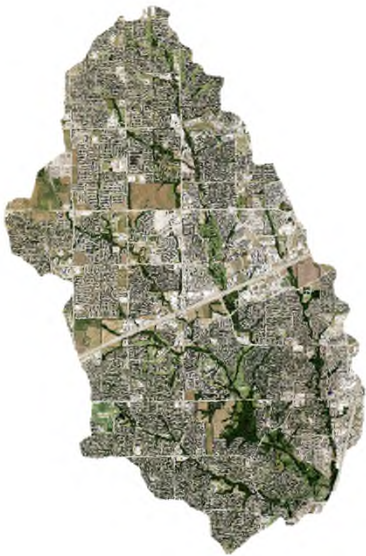
Ortho-imagery (NAIP 2022)

- Spatial datasets - various

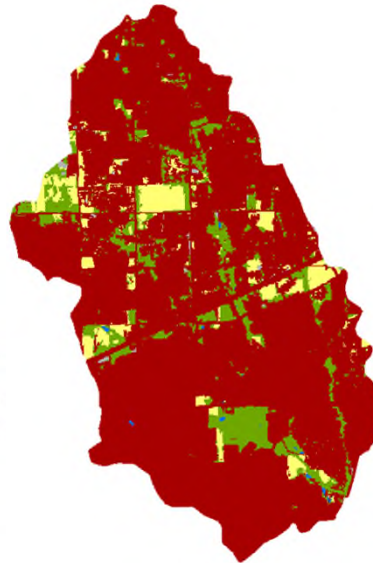
Land Cover (NLCD)

☒ NLCD 2021 study area  
Value  
water  
urban  
barren  
forest  
crops

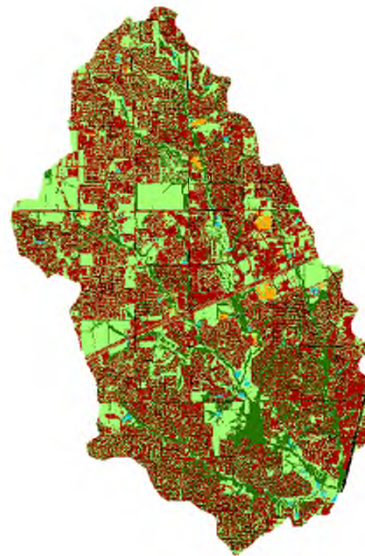
Land Cover (Halff-classified NAIP)

☒ NAIP 2022 study area  
Class  
Water  
Tree Canopy and Shrubs  
Low Vegetation  
Barren  
Impervious Surfaces  
Impervious Roads

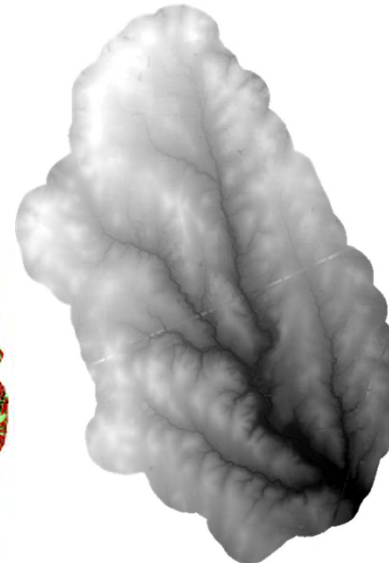
Terrain (LiDAR)

☒ LiDAR terrain study area  
Value  
805.535  
547.051

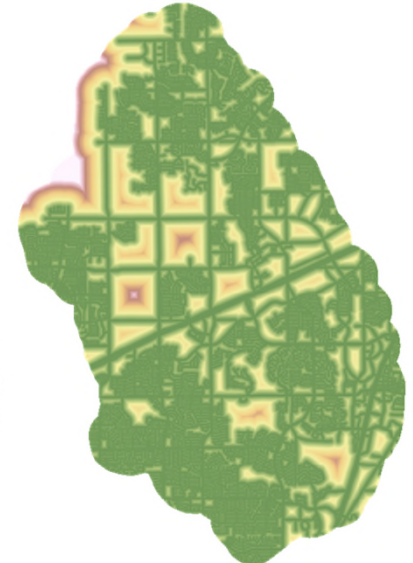
☒ Road Proximity study area  
Value  
4625.33251953125  
0

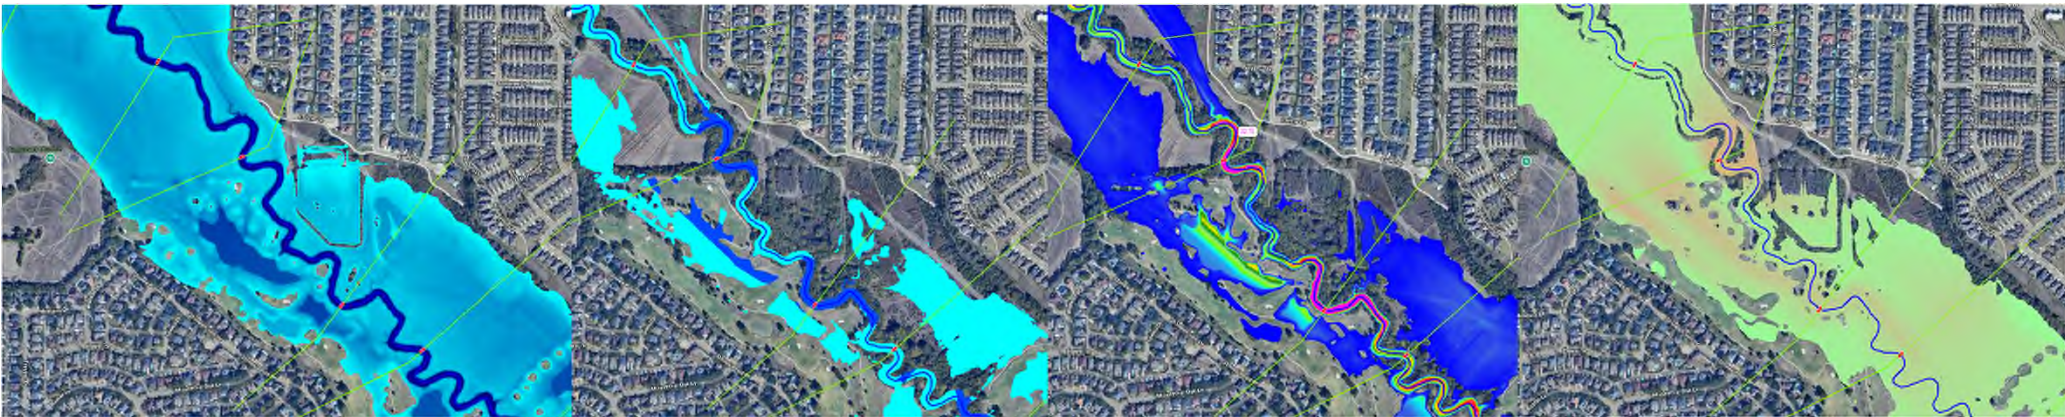
- Hydraulic properties
- Existing detailed studies
- Detailed hydraulic models (2D)
- Condition assessment

Depth

Velocity

Momentum

Stream Power

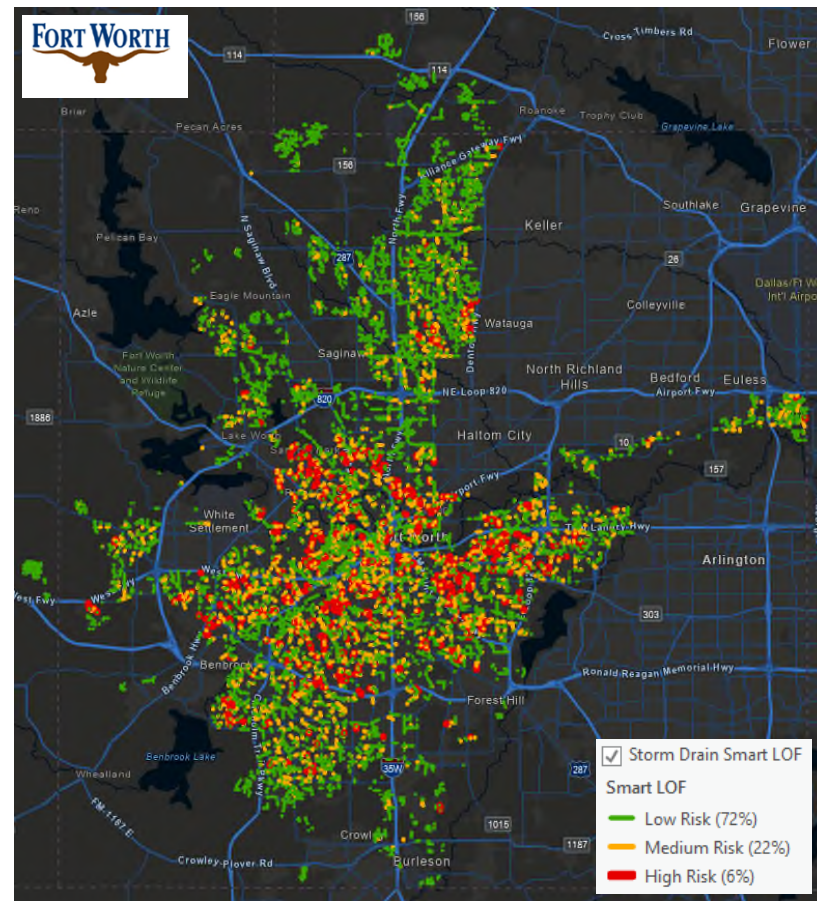
Cross Validation

- Recall (median) = 80% vs 55% with rule-based BRE
- Storm drains in poor condition predicted = 4 of 5
- Future field efforts strategically focused
- Model improves with time

Recall	CV
85%	1
82%	2
81%	3
81%	4
80%	5
80%	6
79%	7
79%	8
78%	9
76%	10

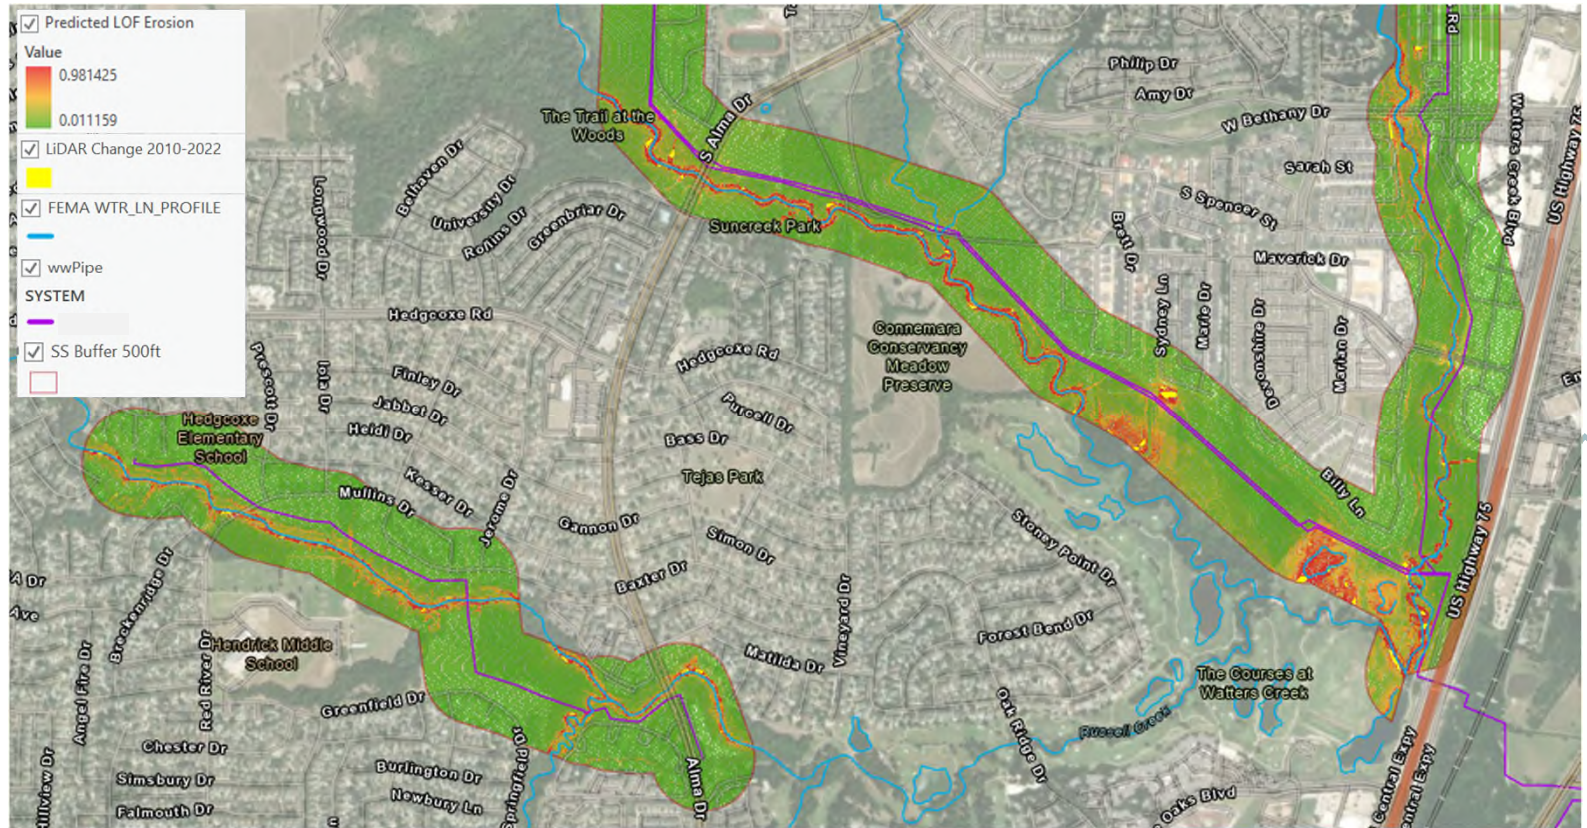
- Predicted Likelihood of Erosion
- Typical model skill ~ 95%

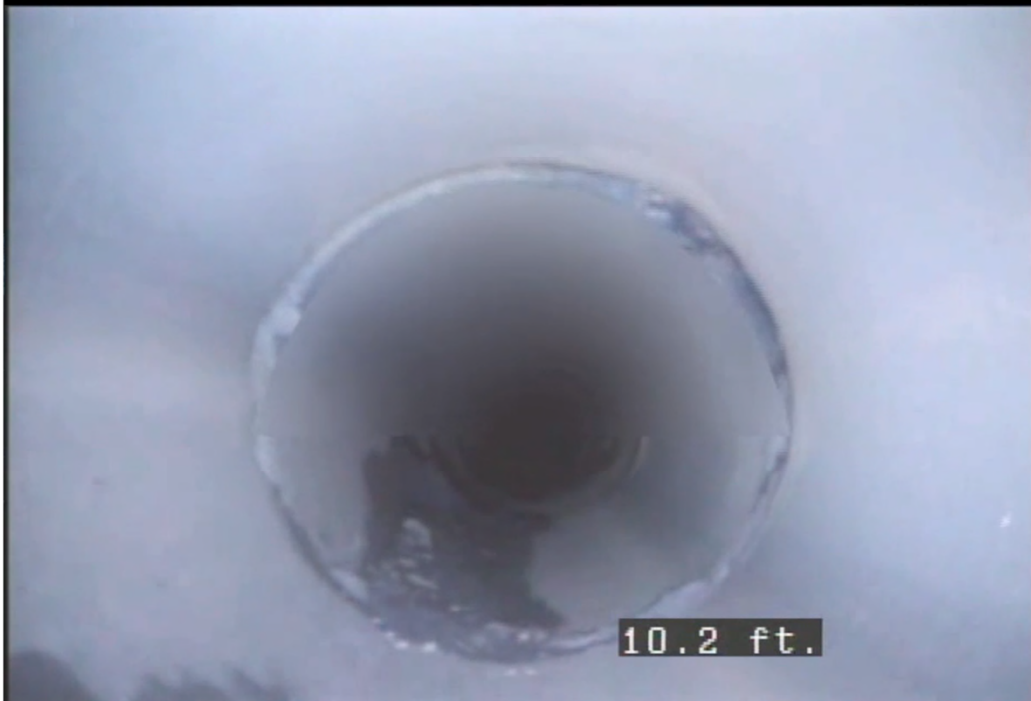
AI Model Overlay

AI QA/QC – Sample #1

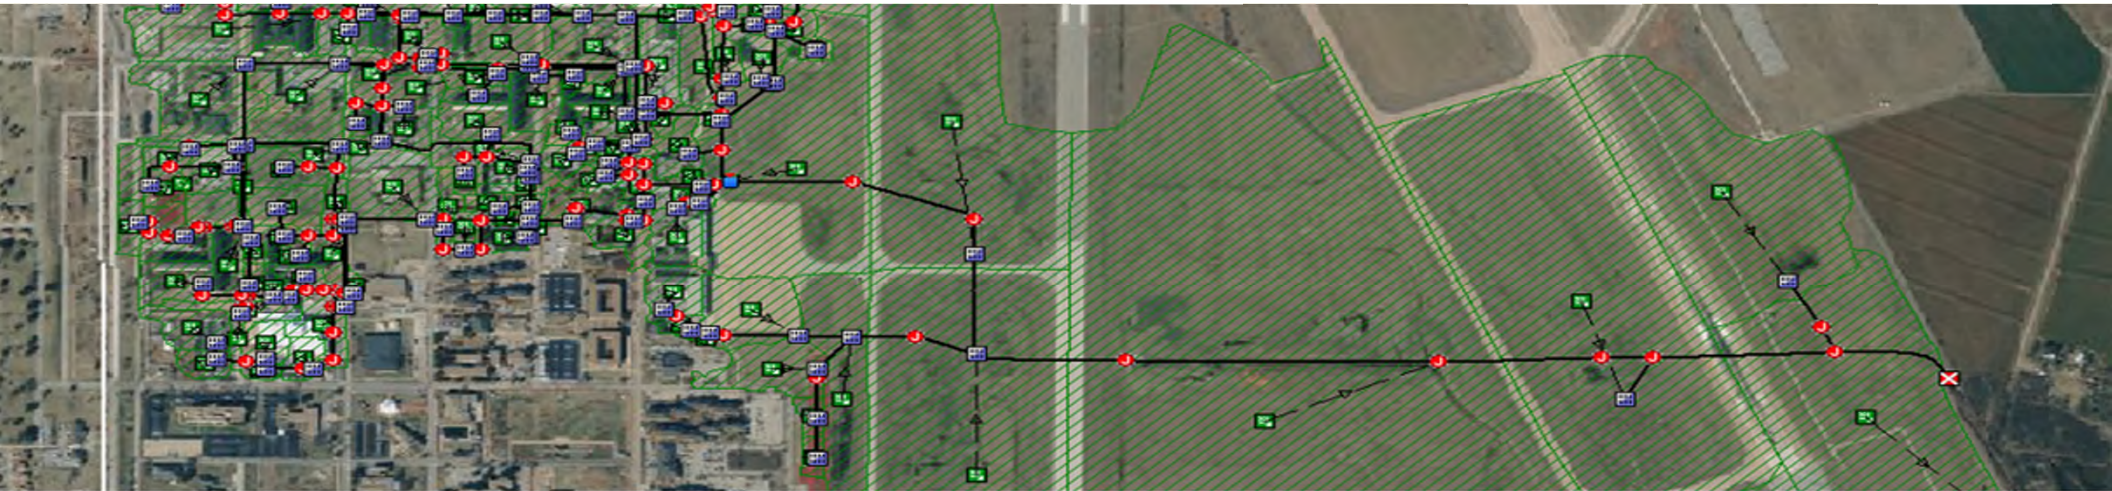
Detailed watershed mapping

GeoBase updates and site visits informed drainage network

Master plan with future pipe sizes
